TEST REPORT: N.AT328PC/15
Sulmona, 10.11.15

LOAD CAPACITY TEST OF LOFT LADDER

CLIENT:	FGM SCALE S.R.L. VIA DELL'ARTIGIANATO, 10 67039 SULMONA (AQ)
DAY OF THE TEST:	27th OCTOBER, 2015
TEST SAMPLE:	AUTOATTIC LOFT LADDER 70x100 H=276-300
RELEVANT LEGISLATION:	UNI EN 14975:2010 "Loft ladders – Requirements, marking and testing"

LOAD CAPACITY TEST REPORT

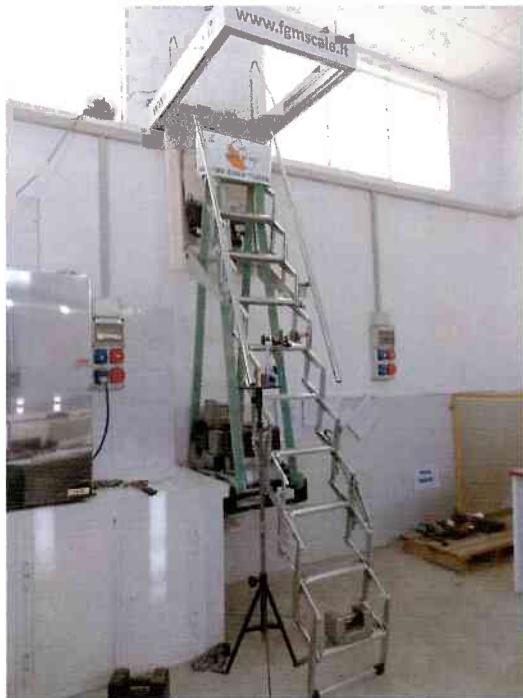
Picture 1: static load test – first step

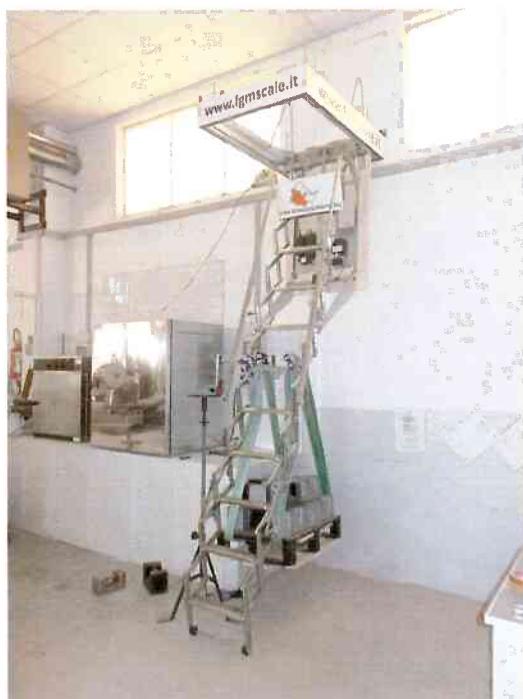
Picture 2: static load test – middle step of the ramp

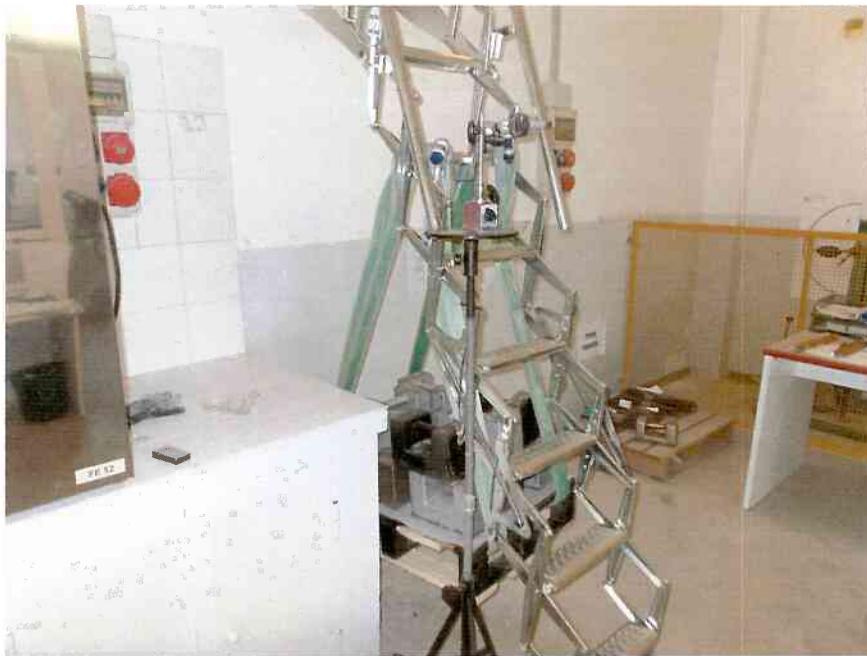
Picture 3: static load test – middle step of the ramp, specific dial gauge

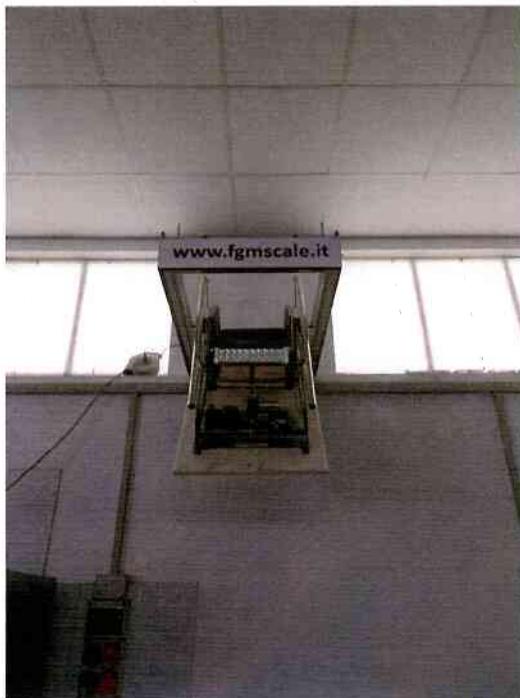
Picture 4: assessment of entirety of opening-closing mechanism

- 9) Assessment of entirety of opening and closing mechanism of the loft ladder.
